*NIST Special Publication 862*

# 1994 Northridge Earthquake

## Performance of Structures, Lifelines, and Fire Protection Systems

*Diana Todd, Nicholas Carino, Riley M. Chung, H. S. Lew, Andrew W. Taylor,  
William D. Walton, James D. Cooper, and Roland Nimis*

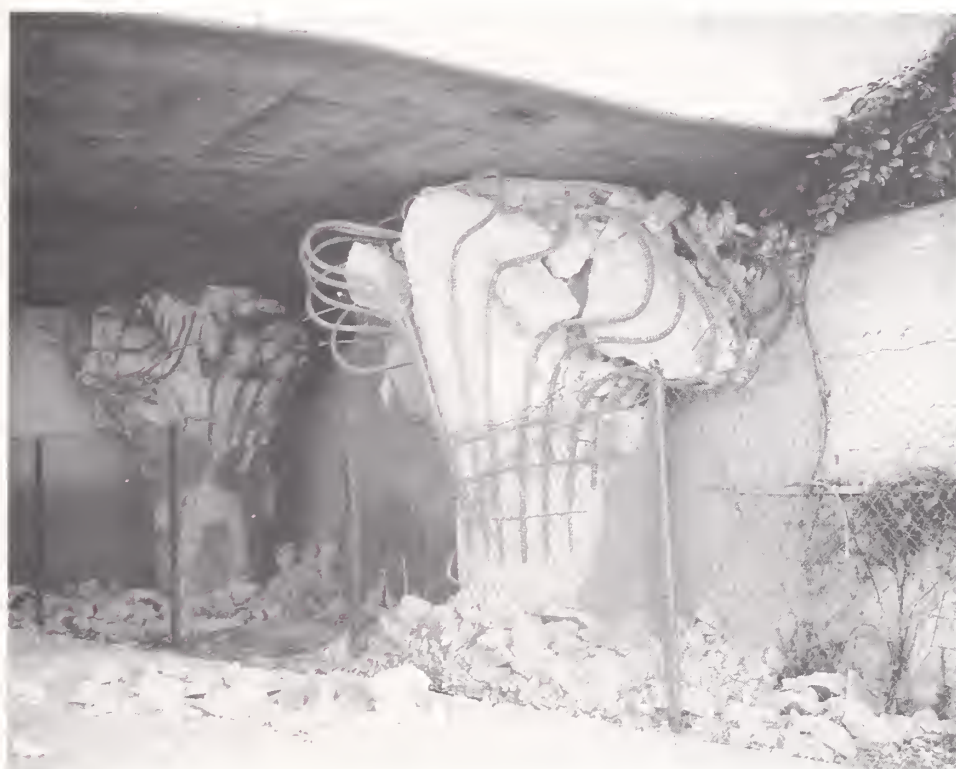
Figure 4.40 shows the northernmost pier of Bent 6, located just to the west of the hinge. This pier totally disintegrated, but the storage building prevented the roadway from collapsing to the ground. Figure 4.41 shows the southernmost pier supporting the eastbound lane at Bent 3. The top of the pier is severely damaged and it is likely that the storage building prevented the total collapse of the roadway.

Figure 4.41. Piers of Bent 3 supporting eastbound lane of I10 at La Cienega Blvd.

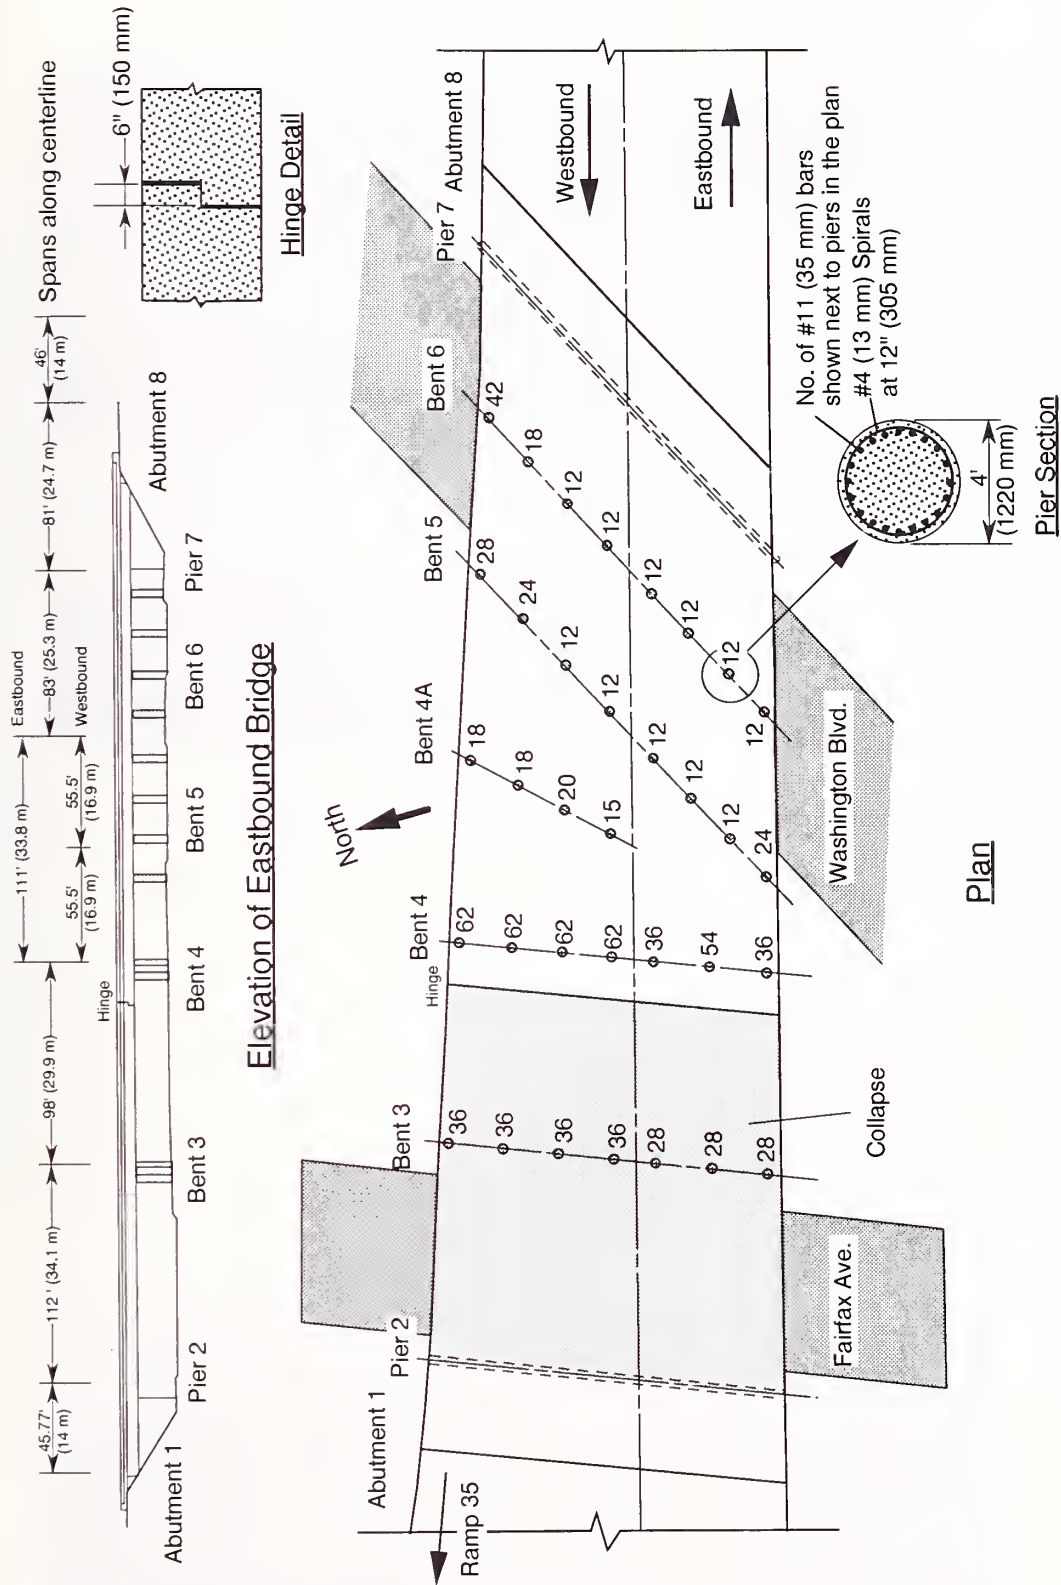
# I-10 Fairfax-Washington Undercrossing

Figure 4.42 shows the elevation and plan of the Fairfax Ave.-Washington Blvd. Undercrossing. The eastbound and westbound lanes of I10 were supported by solid wall piers adjacent to the abutments and by multiple-pier bents at the remaining locations. A construction joint (hinge) was located to the west of Bent 4. Because of the skewed alignment of I10 relative to Washington Blvd., the westbound lane of I10 was designed with an additional bent (Bent 4A) compared with the eastbound lane. The piers were of circular cross section with a diameter of 1220 mm (4 ft). The longitudinal reinforcement consisted of #11 (35 mm) deformed bars. The number of longitudinal bars in each pier is shown adjacent to the pier locations in figure 4.42. It can be seen that the piers in Bent 4 had significantly more longitudinal bars compared with the other piers. The lateral reinforcement was #4 (13 mm) bars at a vertical spacing of 305 mm (12 in).

The earthquake caused partial collapse of two spans of the eastbound and westbound lanes on either side of Bent 3 (fig. 4.42). When the reconnaissance team arrived at the site, the collapsed spans had been completely removed and workmen were preparing to open up traffic on Fairfax Ave. Hence it was not possible to examine the collapsed structure. Conversations with Caltrans engineers at the site revealed that the piers in Bent 3 had failed and caused the girders to sag at this location. However, cable restrainers at the hinge west of Bent 4 prevented the girders from falling off of the hinge seats (fig. 4.43). Figure 4.44 is a photograph provided by EERC which shows the westbound lane of I10 over Fairfax Ave. It can be seen that the piers in Bent 3 shortened and caused the girder to sag. It can also be seen that the span to the west of Pier 2 lifted off of the abutment. Figure 4.45 is a close up view of one of the piers in Bent 3. The failure mode is similar to that observed at Venice Blvd. and La Cienega Blvd. When the piers were subjected to lateral ground motions, the lateral reinforcement was not able to adequately confine the core concrete. As a result of lateral load damage, there was a loss of axial load capacity and the piers shortened under the action of the vertical loads. As mentioned, the piers at Bent 4 had considerably more longitudinal reinforcement than the other piers. Examination of the piers in Bent 4 revealed varying degrees of diagonal cracking and spalling of the concrete cover. At the time of the site visit, these piers were surrounded with wooden shoring as a precautionary measure during the demolition of the collapsed spans.

Figure 4.42. Elevation and plan of I10 at the Fairfax Ave./Washington Blvd. Undercrossing.

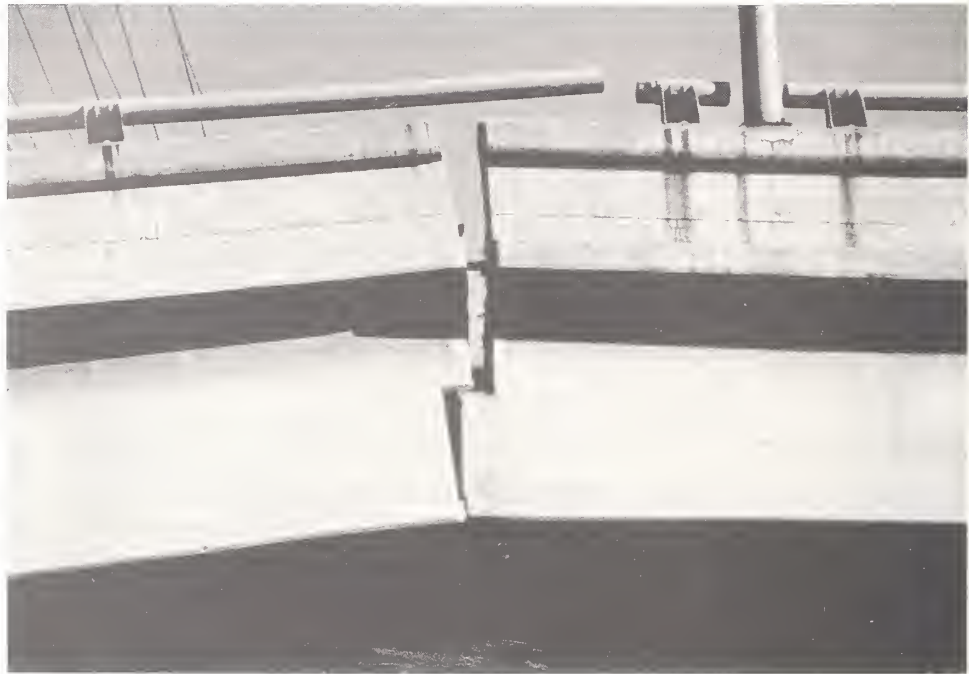
Figure 4.43. Hinge adjacent to Bent 4 of I 10 at Fairfax Ave.; cable restrainers prevented loss of support (Photo courtesy of EERC).

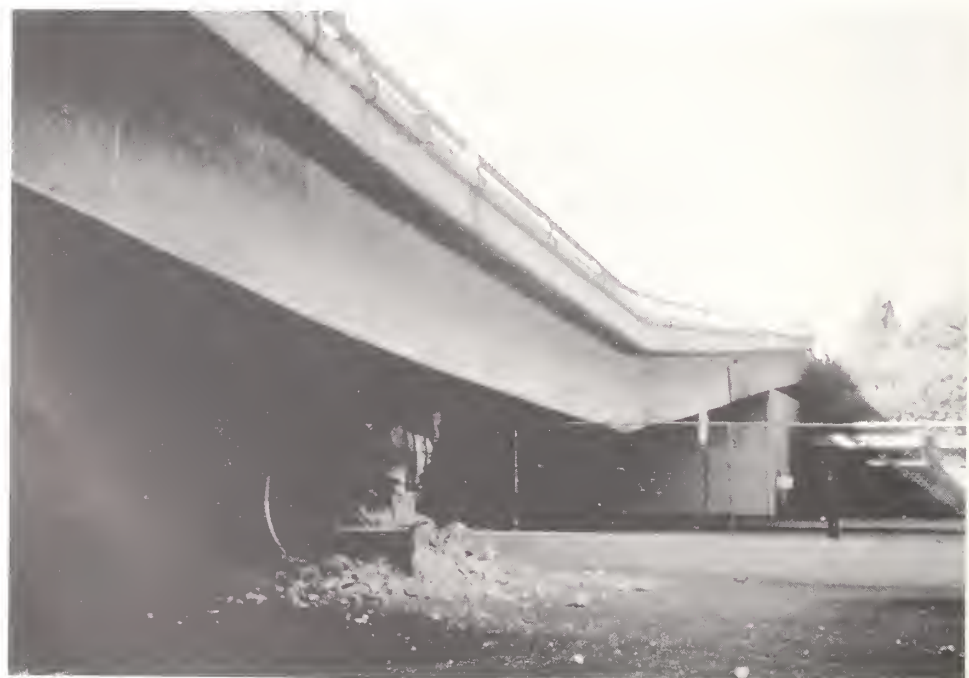
Figure 4.44. View of collapsed span of I10 over Fairfax Ave.; note rotation of girder over Pier 2 (Photo courtesy of EERC).

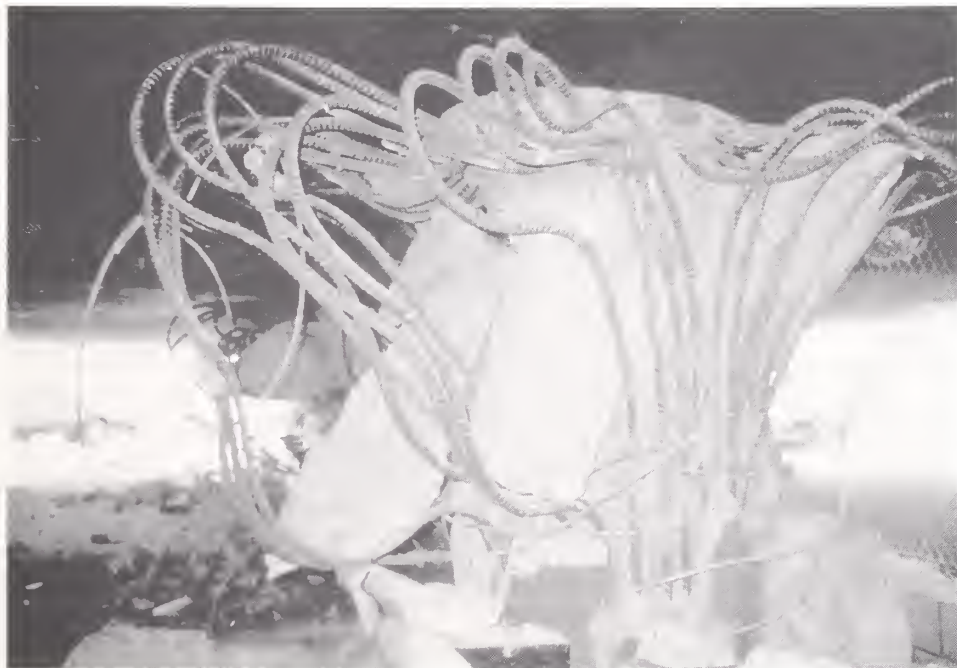
Figure 4.45. Failed column in Bent 3 of I10 at Fairfax Ave. (Photo courtesy of EERC).

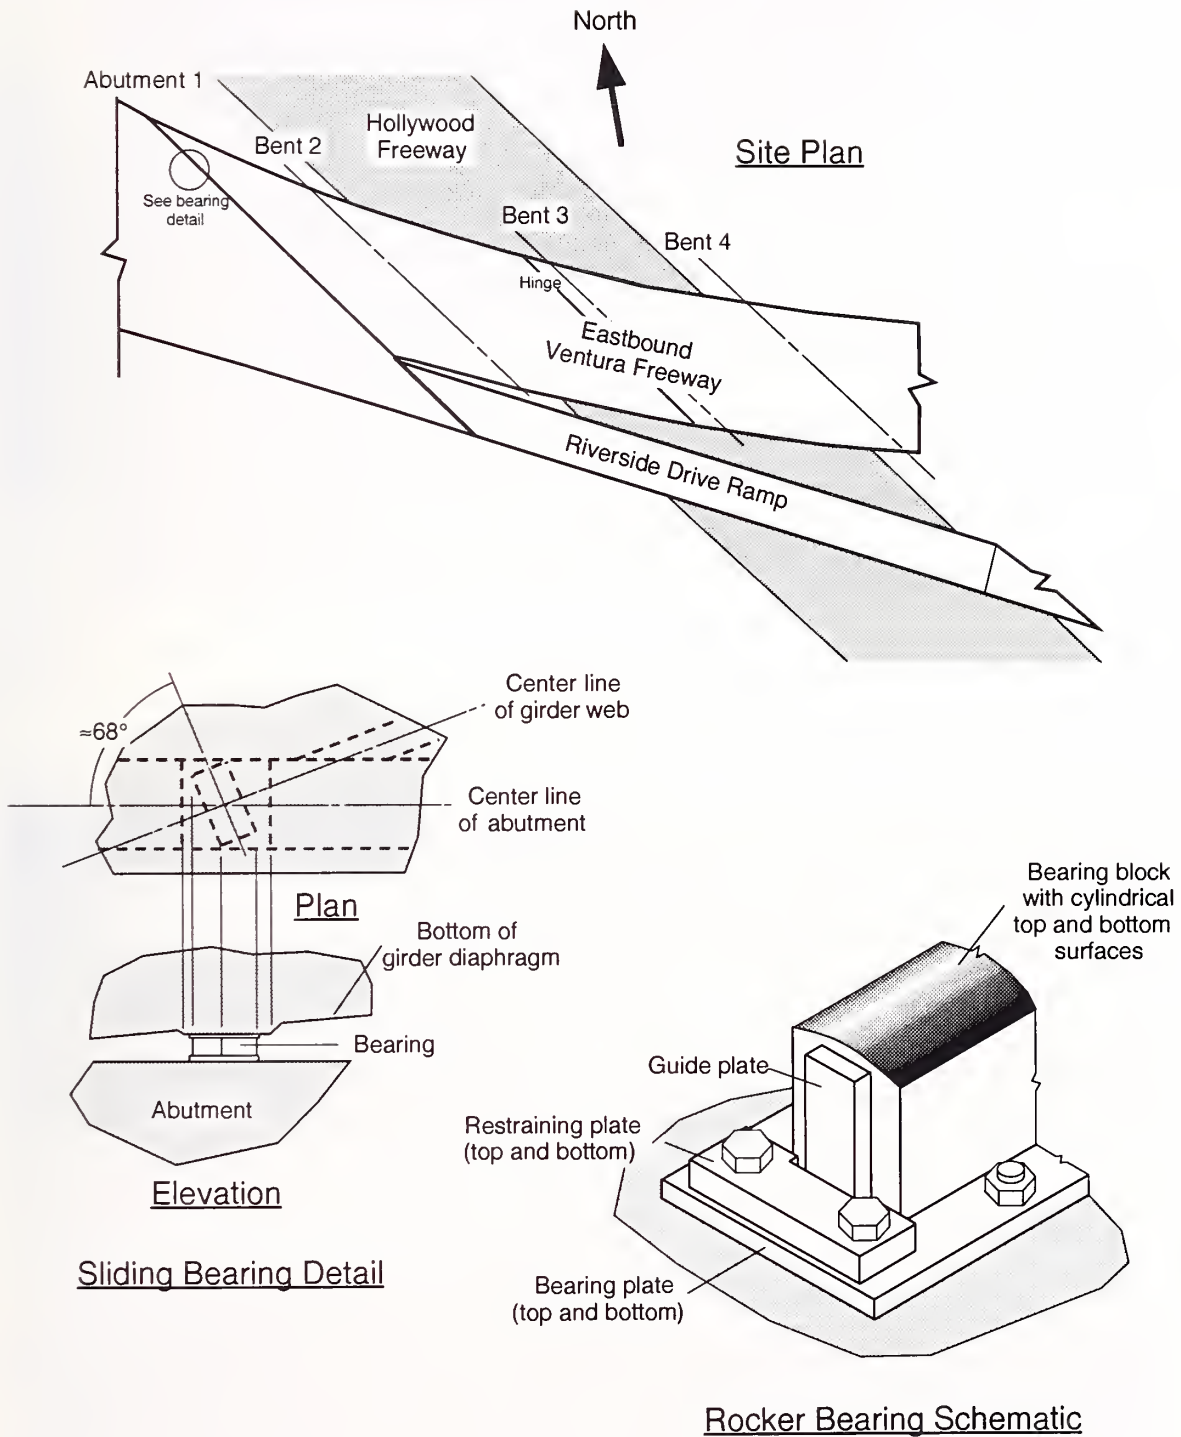
Figure 4.46 shows a simplified plan of the eastbound lane of the Ventura Freeway and the Riverside Drive ramp. Figure 4.47 is a ground level view of the eastbound lane as seen from the northbound lane of the Hollywood Freeway. At Abutment 1 (fig. 4.46), bearing supports are provided at the locations of the webs in the box girder. As shown in figure 4.46, the longitudinal axes of the bearings are aligned at right angles to the longitudinal axes of the girder webs. The four bearings on the north side of the eastbound lane of Ventura Freeway are of the sliding-type. Figure 4.48 shows the type of damage that was observed at these locations. Apparently, the dynamic frictional resistance of the bearing resulted in forces sufficient to spall off the shell of the abutment. The remainder of the bearings supporting the eastbound lane and the Riverside Drive ramp are of the rocker type. Figure 4.46 shows a schematic of this type of bearing. A steel bearing block with cylindrical surfaces is located between steel plates set into the abutment and girder end diaphragm. The blocks are kept in position with a system of guide plates and restraining plates as shown in figure 4.46. All of the rocker bearings showed some type of earthquake damage. The bolts for the restraining plates were sheared off at many locations, and the sheared bolt heads were found at distances of up to several meters from their original position. Some of the bearing blocks were skewed from their original positions (fig. 4.49). In one case, the bearing block had tipped over resulting in a complete loss of support at that location (fig. 4.50).

Figure 4.46. Eastbound lane of Ventura Freeway crossing over Hollywood Freeway; site plan and bearing details.

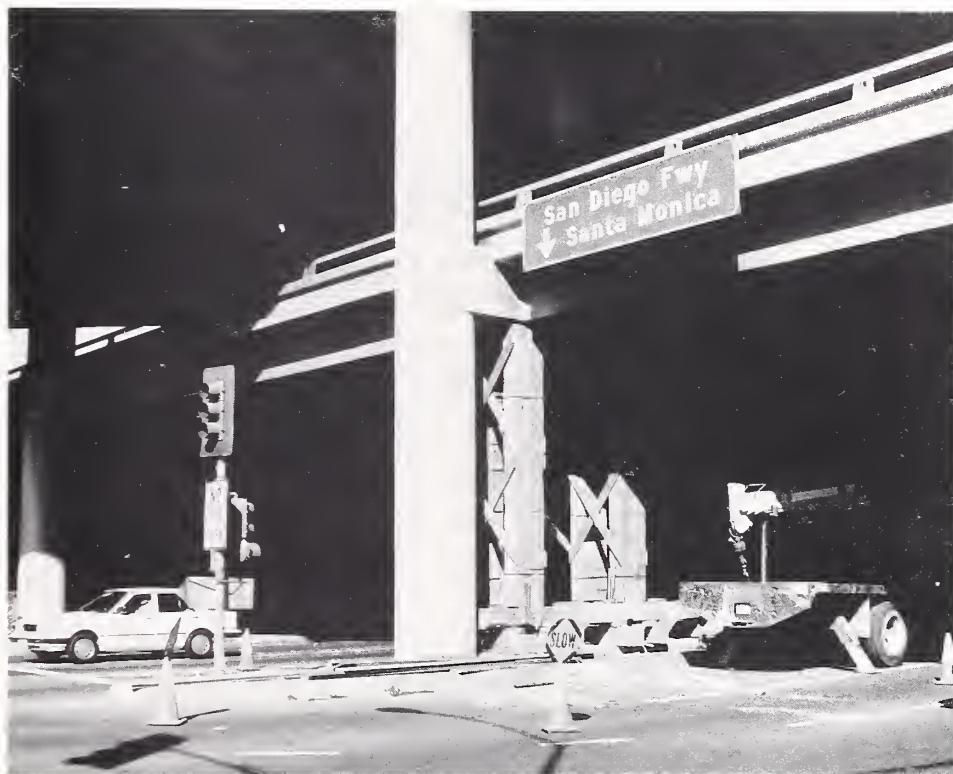
This is a cast-in-place reinforced concrete bridge which carries Interstate 405 over Jefferson Blvd. The bridge consists of four spans: two 8.5 m (28 ft) long end spans and two 16.0 m (52.5 ft) long center spans. The bridge is supported on three six-pier bents, making a total of 18 piers. The piers are circular and 1220 mm (4 ft) in diameter. All but two of the eighteen piers have structural hinges at the top of the pier footing. The outer piers of each bent are located outside the bridge girders, creating an "outrigger" configuration, as shown in figure 4.53. After the Northridge earthquake, diagonal cracks were observed in all six outrigger joints at the ends of the three bents. The cracking was most serious on the east end of the center bent. A close-up photograph at that location are shown in figure 4.54.

The damage observed in the Northridge earthquake possibly arose from three factors. First, the joint regions where cracking occurred are not as heavily reinforced as they would be under current design standards. Second, the structural hinges at the bases of most outrigger piers tended to increase the moments imposed on the outrigger joints. Third, the Jefferson Blvd. Undercrossing shares piers with the SR90 ramp above, as shown schematically in figure 4.55. The upper SR90 structure is more flexible than the lower Jefferson Blvd. Undercrossing, possibly resulting in further concentrations of moments at the outrigger joints.

Figure 4.53. Overview of the outrigger joint at the SR90/I405 interchange, Jefferson Boulevard Undercrossing, center bent, west side, looking to the north.

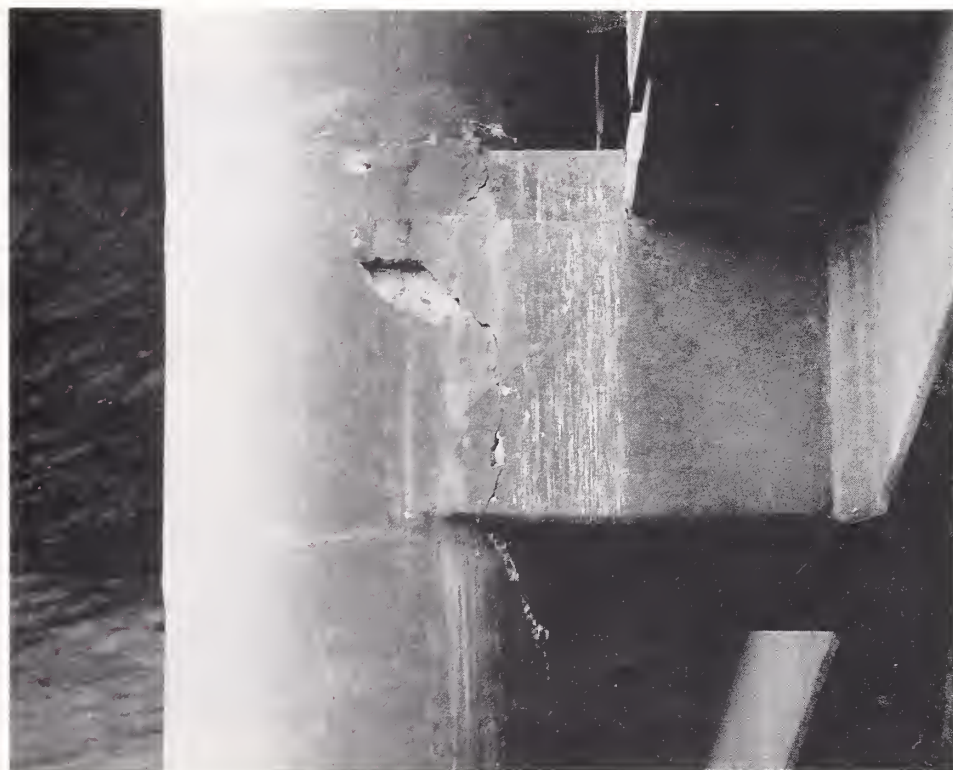
Figure 4.54. Close-up of the outrigger joint at the SR90/I405 interchange, Jefferson Boulevard Undercrossing, center bent, east side, looking to the south.

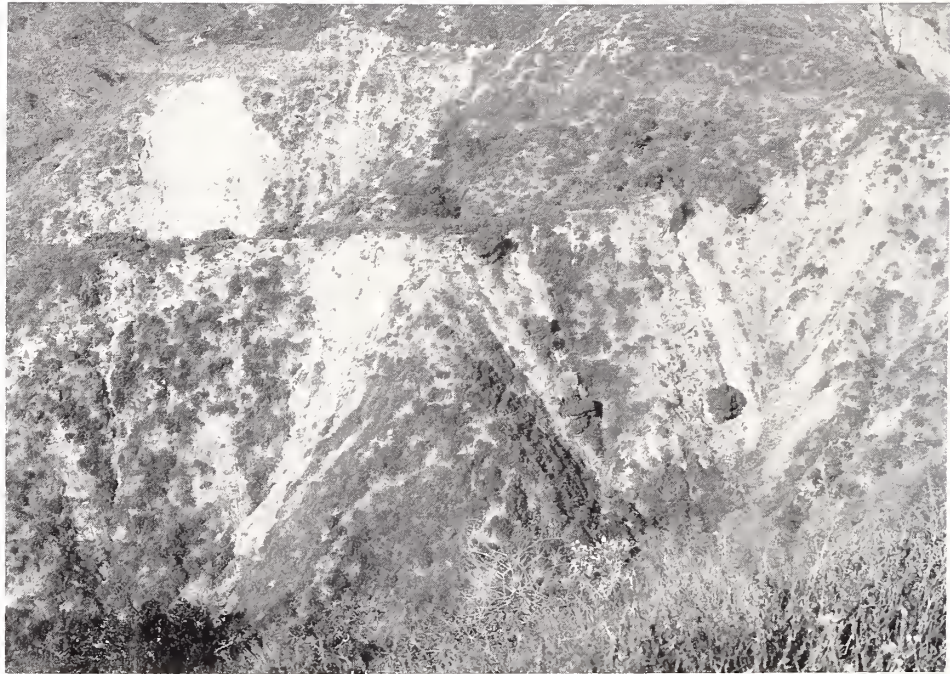
Among the numerous situations that contributed to the disruption of the water supply system was damage to Los Angeles Aqueduct No. 2 at Terminal Hill. Aqueduct No. 2 is made of 2.1-m (77 in) diameter steel pipes. Terminal Hill is located about 20 km (12.5 mi) north-northeast of the epicenter, southeast of the intersection of I5 and SR14. There is no strong motion record available for the site. However, two stations maintained by the California Division of Mines and Geology (CDMG) and the U.S. Geological Survey (USGS) about 5 km (3 mi) south of the site showed peak ground accelerations over 0.9g, indicating that the site probably was strongly shaken by the earthquake. Other indications of strong shaking can be seen from the numerous landslides along the mountainside to the north of the site (fig. 5.1), and the bridge failures at the intersection of I5 and SR14.

Figure 5.1. Strong shaking at Aqueduct No. 2 at Terminal Hill can be inferred from the numerous landslides along the mountain slopes to the north of the site.

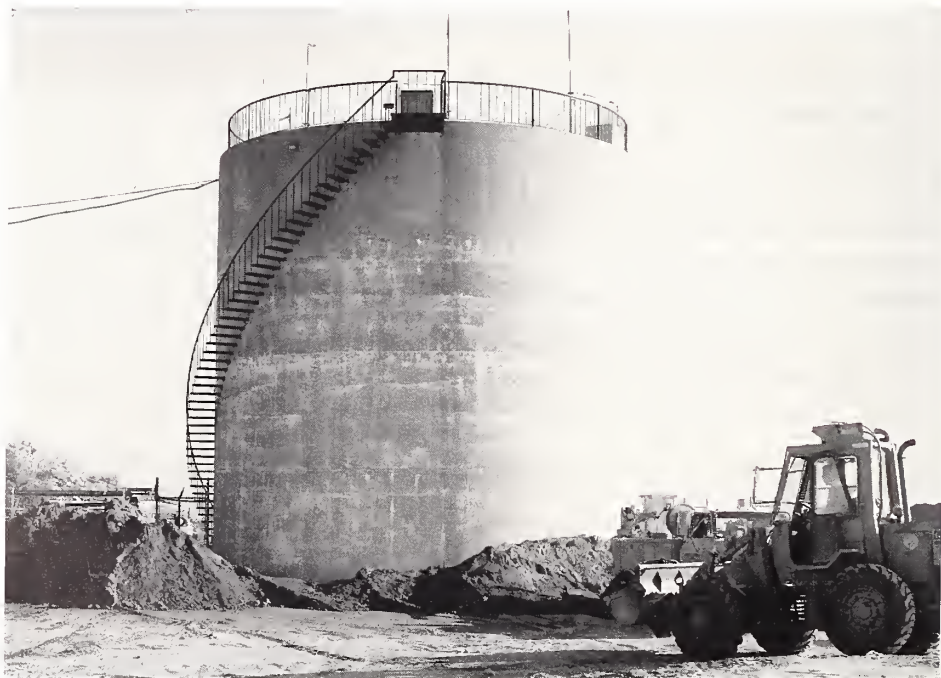
The reinforced concrete relief tank (surge chamber) on top of the hill appeared to perform well through the earthquake--no damage was observed (fig. 5.2). A steel pipe brings water up from the canyon below (fig. 5.3). The pipe is supported on concrete saddles built along the mountain slope. At a few places, the pipe separated from the saddles creating 50 to 80 mm (2 to 3 in) gaps. In at least one location, the pipe crashed vertically into the saddle. At two other locations, the pipe sections bulged 80 mm and 150 mm (3 and 6 in), however, no rupture or leakage was noticed. The ruptured section of the 2.1-m pipe is located near the hilltop. The two sections where the rupture occurred were connected using a mechanical coupling system (fig. 5.4). The pipe sections were connected by eight pairs of restrainer rods 35 mm (1-3/8 in) in diameter and 2.2 m (7 ft) long. The rods were attached to brackets, which were welded to the pipes. These welds broke during the earthquake (fig. 5.5) and resulted in the separation of the two pipe sections.

Figure 5.2. The reinforced concrete surge tank at Terminal Hill performed well during the earthquake--no damage was observed.

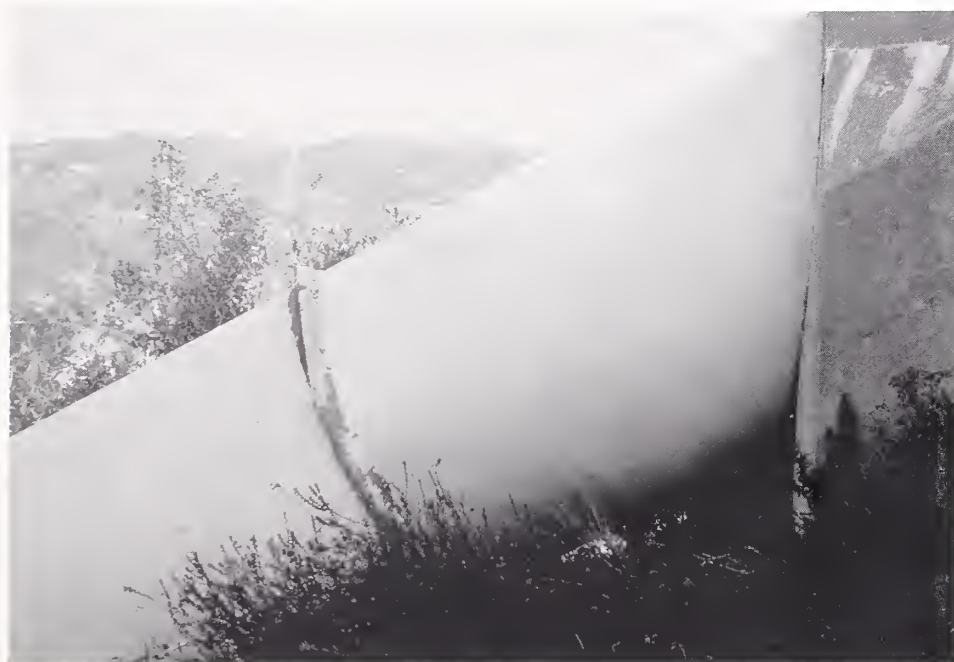
Figure 5.3. The steel pipeline at Terminal Hill separated from its supporting saddle at several places and pipe sections bulged at other locations along the alignment.

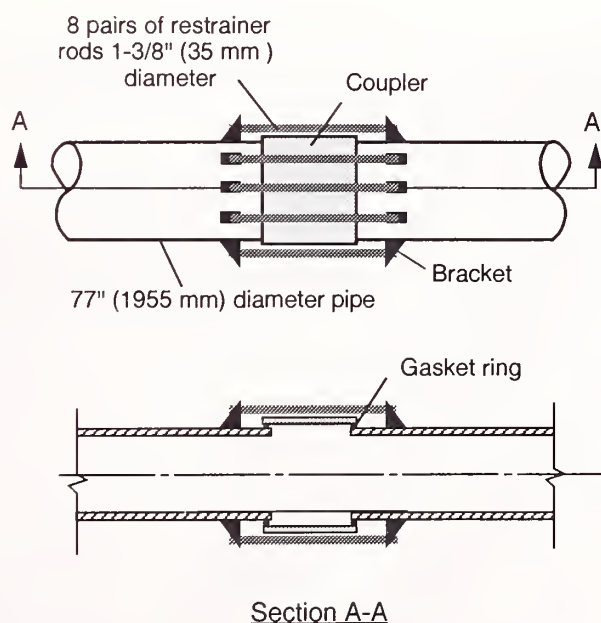
Figure 5.4. Schematic drawing of connection of the two steel pipe sections which were pulled apart during the earthquake.

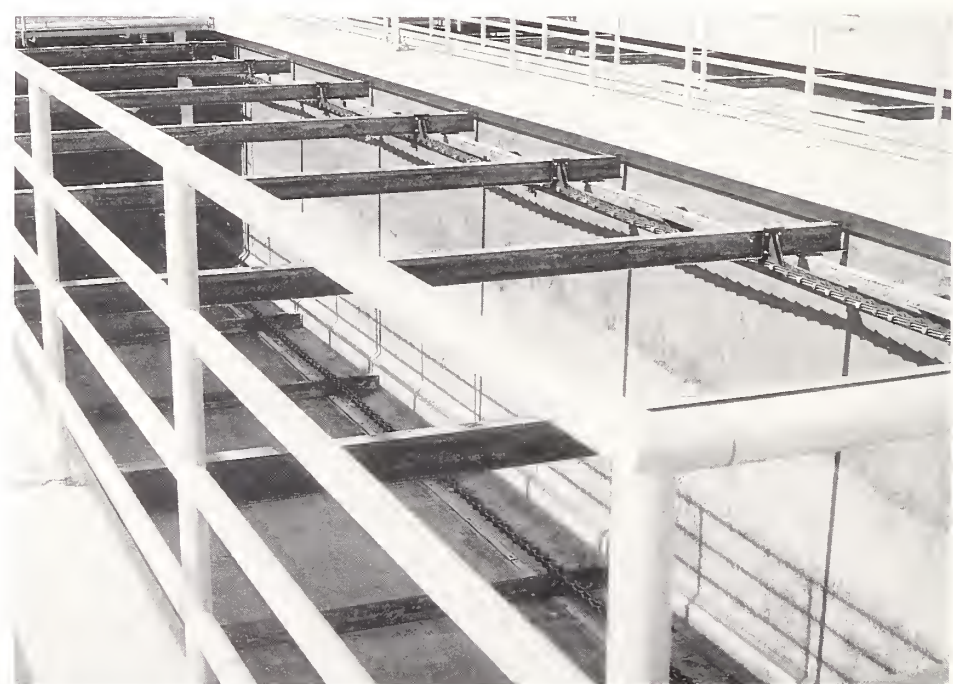
The earthquake resulted in damage to five out of twenty-two final clarifier tanks built in 1991 as part of the Phase II expansion. Twenty-two Phase I tanks built in 1983 were not damaged. Figure 5.6 shows a typical undamaged final clarifier tank. The scrapers are supported by railings attached to the walls with brackets. Chains are used to move the scrapers. All these components were made of plastic in the Phase II construction, whereas the brackets were made of metal and railings and sludge scrapers were made of redwood in the Phase I construction. Pins about 10 mm (3/8 in) in diameter and 19 mm (3/4 in) long connected the brackets to the railings. In the tanks where there was damage, it is suspected that the pins dislodged due to wave action in the tank and the railing became displaced. This caused jamming of the chain movement, which disabled the system (fig. 5.7).

Figure 5.6. Undamaged clarifier tank at the Tillman Water Reclamation Plant.

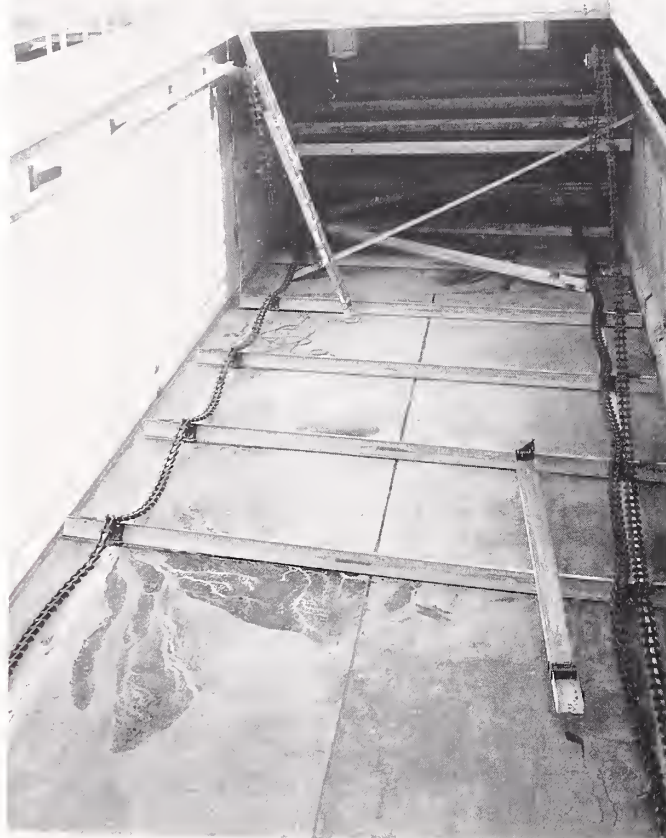
Figure 5.7. A damaged sludge scraper in a clarifier tank at the Tillman Water Reclamation Plant.

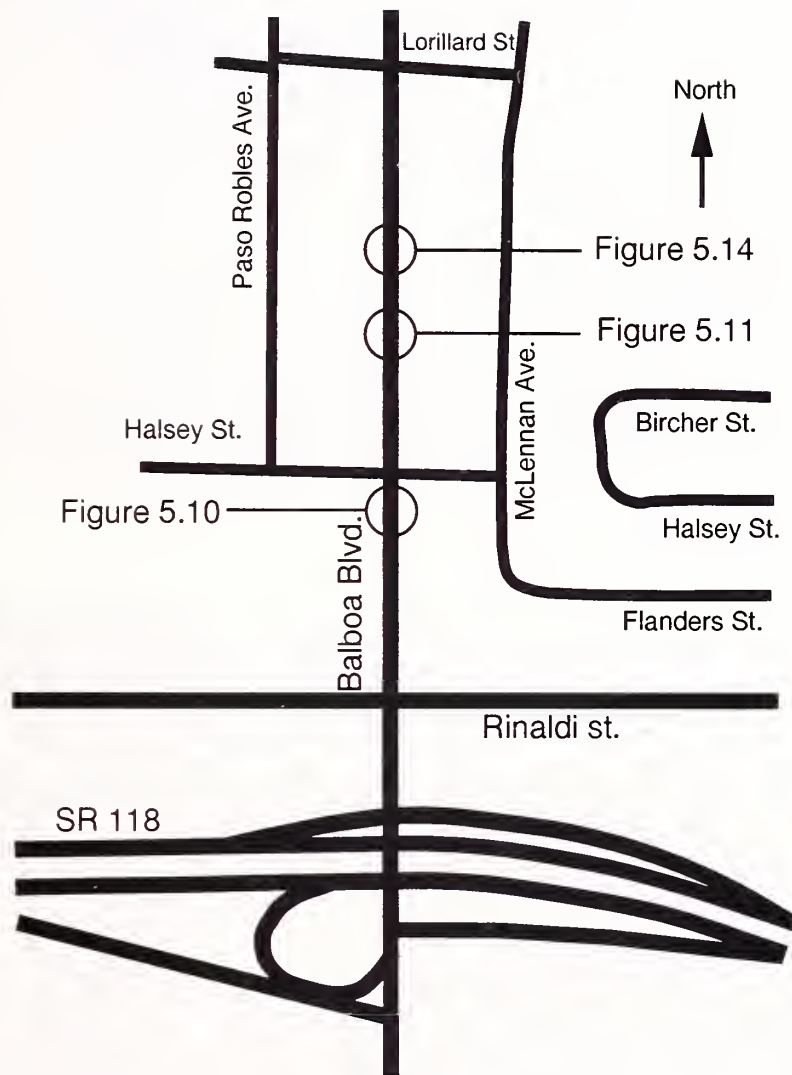
The rupture of a 0.6-m (22-in) gas main occurred along Balboa Boulevard between Rinaldi Street to the south and Lorillard Street to the north (fig. 5.8). Along this stretch, compressional ground failures occurred between Rinaldi Street and Halsey Street, and extensional ground failures occurred between Bircher Street and Halsey Street. Ground extension at this location is prominently exhibited by the transverse cracks in the pavement as shown in figure 5.9. Further, lateral spreading of 25 to 100 mm (1 to 4 in) toward the west was observed along the sidewalk on the west side of Balboa Boulevard north of Halsey Street, whereas no lateral spreading was observed on the east side of Balboa Boulevard.

Figure 5.8. Location of the 0.6-m gas main rupture on Balboa Boulevard.

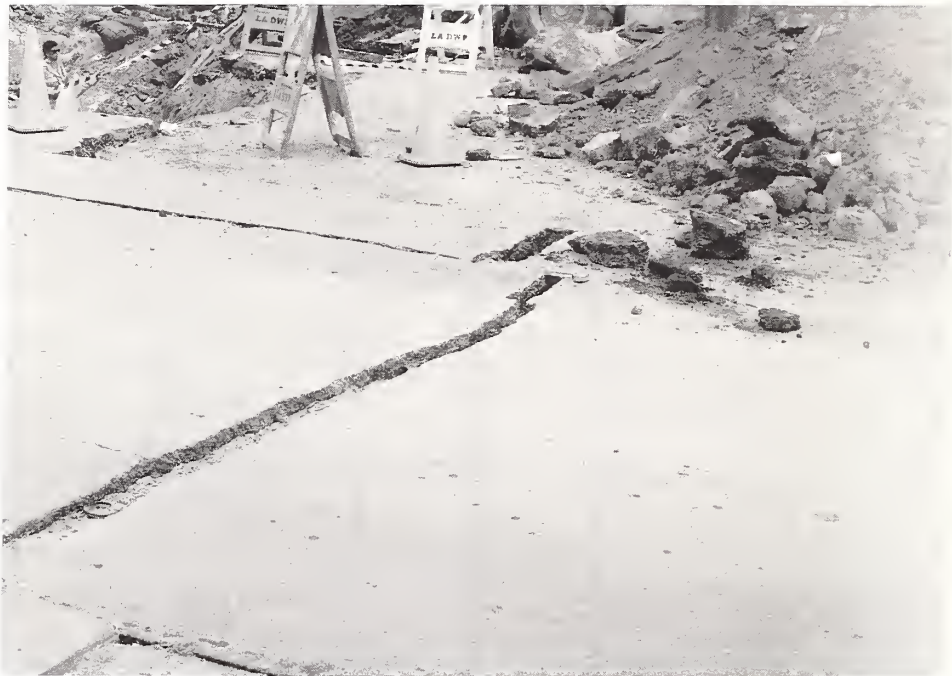
Figure 5.9. Ground extension at the gas fire site on Balboa Boulevard can be seen by the transverse cracks in the pavement.

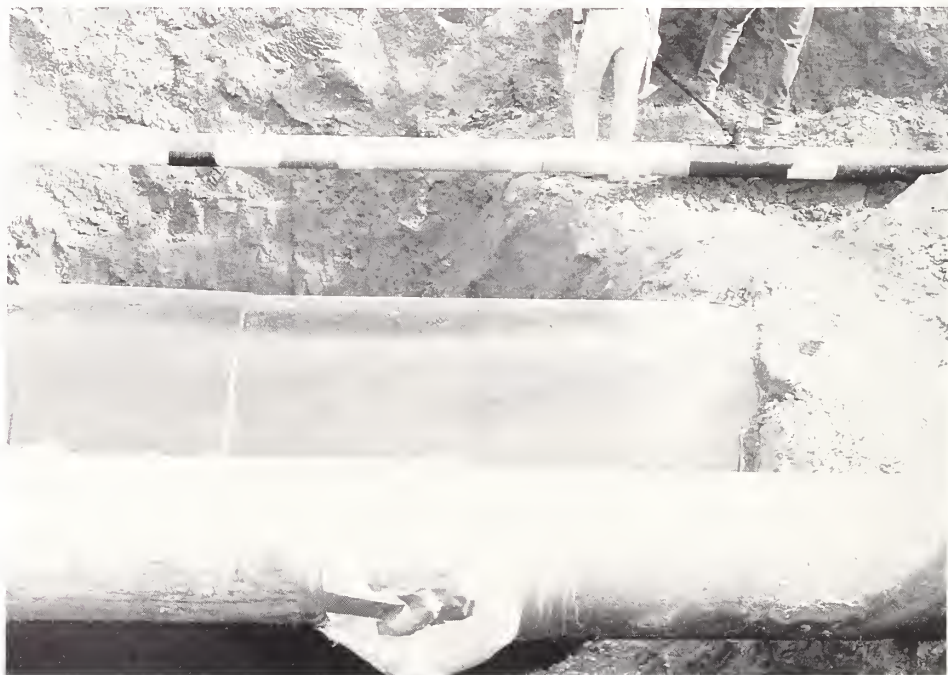
Three pipelines ruptured as the result of ground contraction; a 150-mm (6-in) gas distribution line, the 1.8-m (68-in) Rinaldi trunk water line, and a 0.6-m (22-in) gas main (fig. 5.10). The Rinaldi trunk line was of post-1971 construction, and the gas main was of 1930 vintage. These pipes showed a shortening of 125 to 150 mm (5 to 6 in).

Figure 5.10. Ground contraction along Balboa Boulevard caused the rupture of a gas distribution line (top), the Rinaldi trunk 1.8-m (68 in) water main (center), and a gas main (bottom). The pipes were being repaired at the time this photograph was taken.

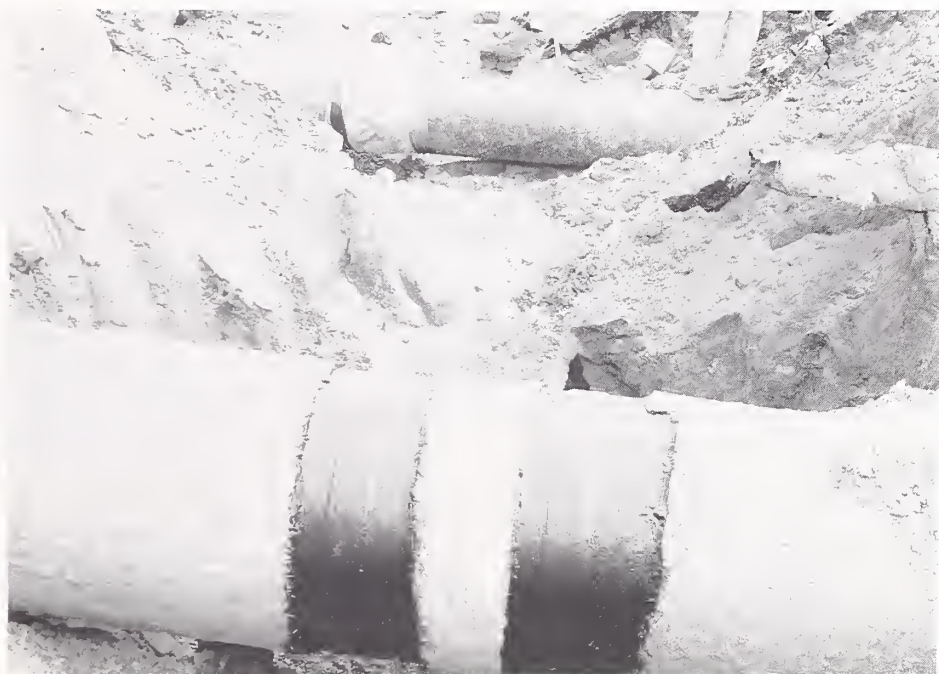
About one block north, the ground extension caused rupture of the same 0.6-m (22-in) gas main and a 1.2-m (48-in) water main (fig. 5.11). These pipes were pulled apart as the result of the ground extension. The rupture of the gas main caused a major fire at the site that destroyed five houses (figs. 5.12 and 5.13). The loss of both water mains at this location and the difficult access to the site due to the fire and street flooding made fire fighting difficult.

Figure 5.11. Ground extension along Balboa Boulevard resulted in the rupture of the same gas main shown in figure 5.10 (top) and a 1.2-m (48 in) water main (bottom). The rupture of the gas main here caused a major fire that engulfed five houses.

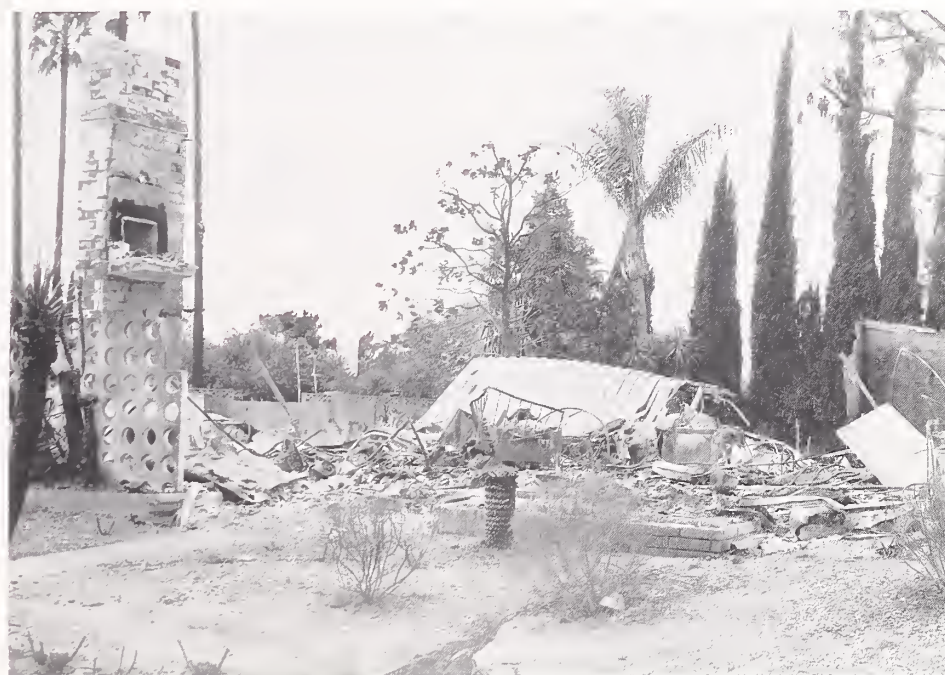
Figure 5.12. Houses destroyed by a fire resulting from the rupture of the 0.6-m gas main along Balboa Boulevard.

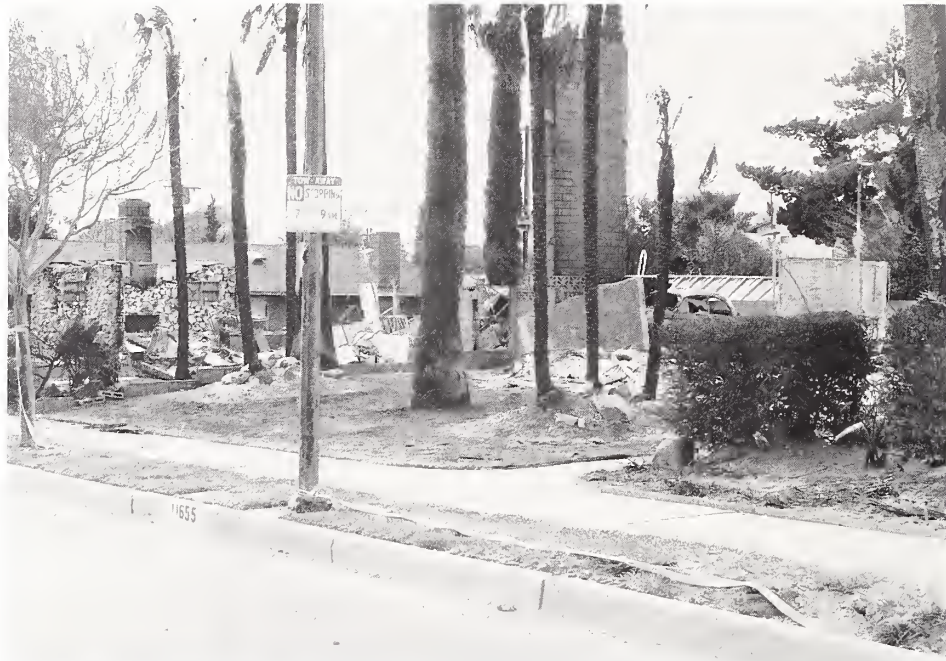
Figure 5.13. Houses destroyed by a fire resulting from the rupture of the 0.6-m gas main along Balboa Boulevard.

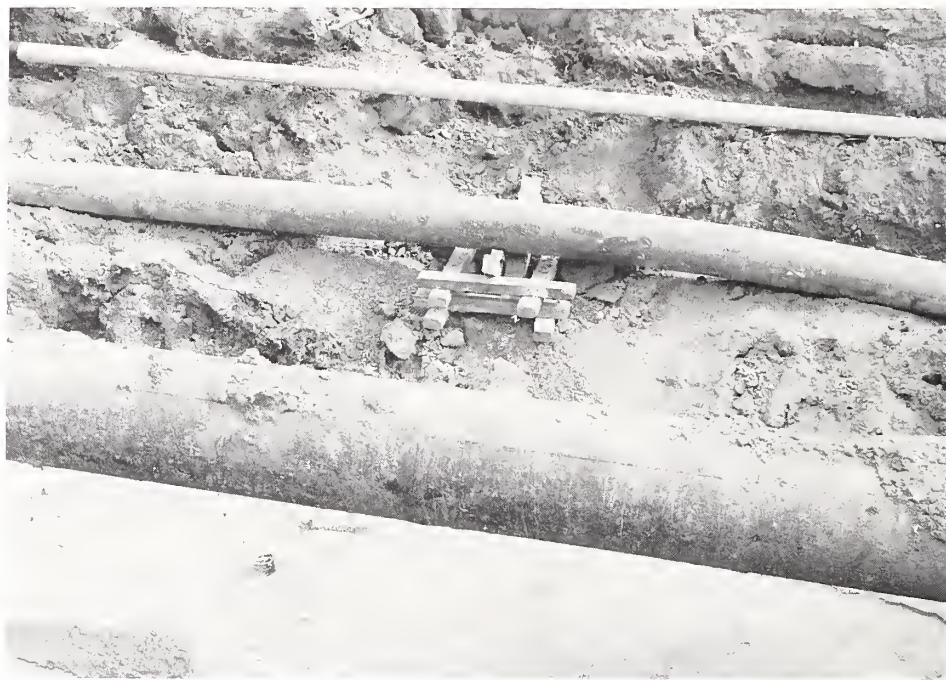
An excavated section just north of the fire site revealed some additional underground lines (fig. 5.14). The 460-mm (18-in) crude oil line in the middle of the photo performed well. The 150-mm (6-in) gas distribution line shown at the top of the photo is a replaced section.

Figure 5.14. Some of the buried pipelines located near the intersection of Balboa Boulevard and Bircher Street showing the potential hazard of co-location of lifeline systems. At this site are three water lines (two of them main lines); three gas lines; two sewers; one crude oil line; overhead power, telephone, and cable TV lines; the street lighting system; and the street itself.

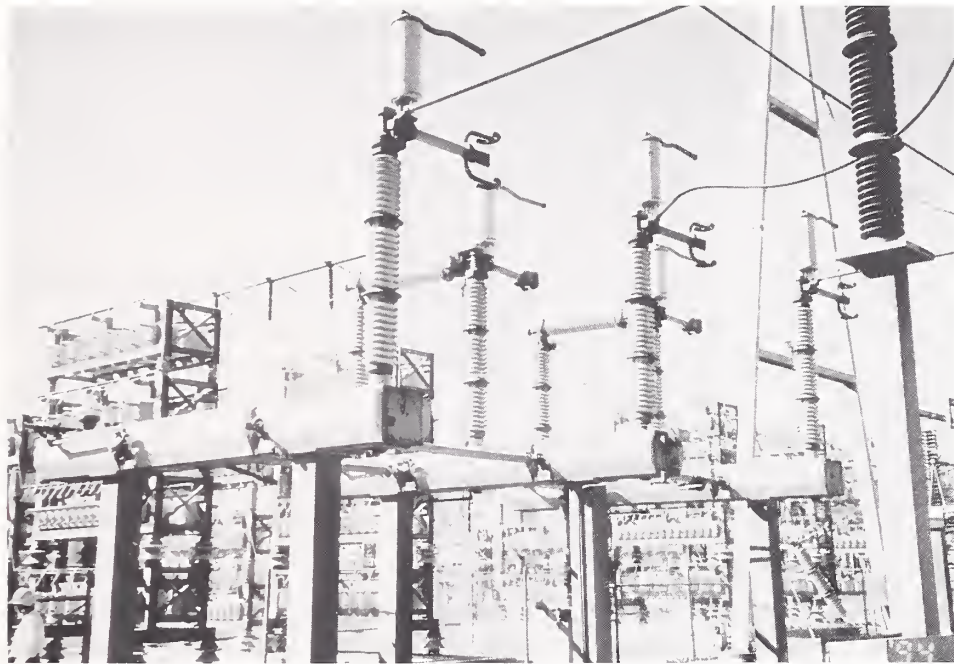
Figure 5.17. Most of the 230-kV circuit switchers (in the forefront) at the Sylmar substation were damaged. Most of the capacitor banks (in the background) performed well in this earthquake, whereas most collapsed during the 1971 quake. (Photo courtesy of Edward Matsuda of Pacific Gas and Electric Company.)

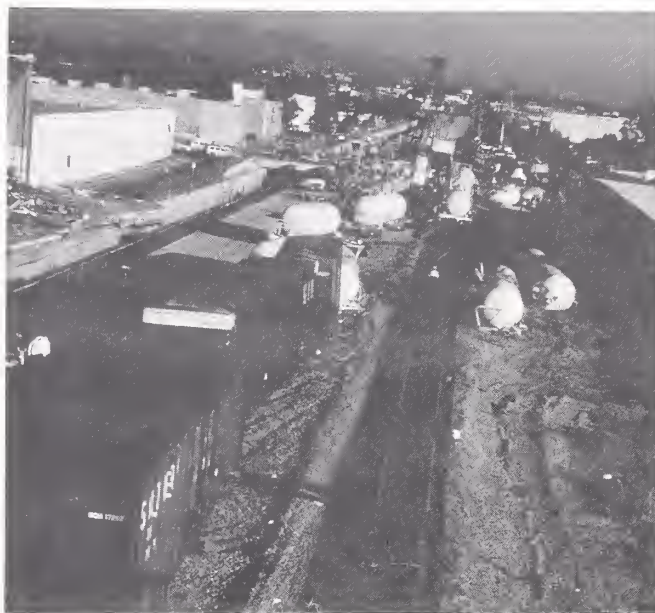
The earthquake caused a freight train derailment in Northridge (fig. 5.18). The 64-car freight train belonged to the Southern Pacific Railroad and was on its way from Houston to Sacramento. Twenty-five cars derailed, sixteen of which carried sulfuric acid or diesel fuel. The derailment resulted in the spill of 30 000 L (8000 gal) of sulfuric acid and 7500 L (2000 gal) of diesel fuel. There were no casualties in this incident. About 200 m (650 ft) of railroad tracks were replaced immediately following the earthquake and rail service was restored at 2:00 a.m., January 19. Removal of damaged cars and cleanup of debris were completed on January 21.

Figure 5.18. Derailment of a 64-car freight train in Northridge. The incident resulted in the spill of 30 000 L of sulfuric acid and 7500 L of diesel fuel. (Photo courtesy of LeVal Lund.)

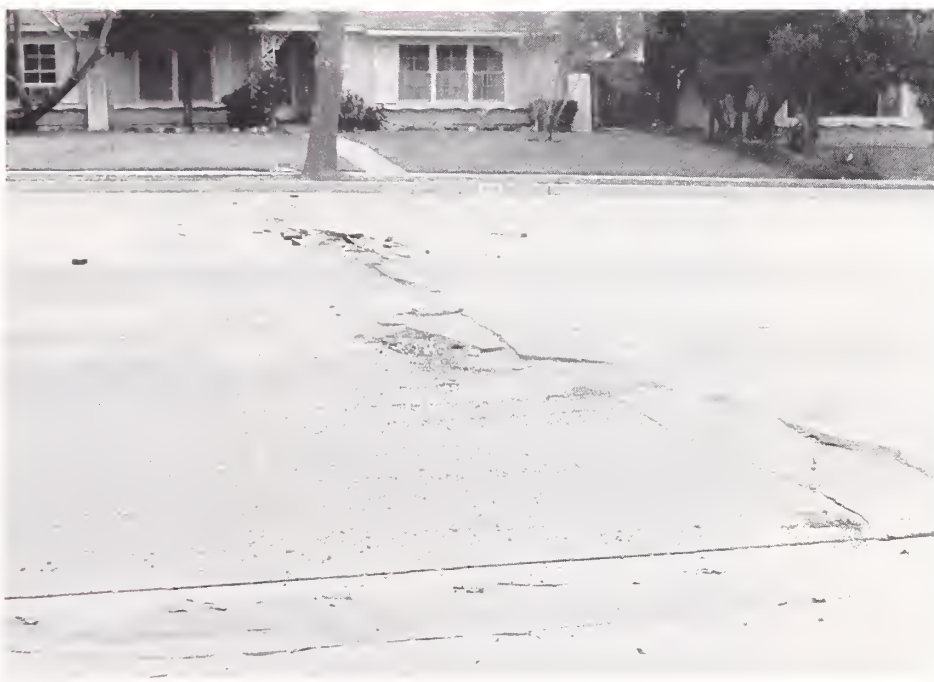
Strong ground shaking and lateral movement of subgrade materials resulted in numerous ruptures of asphalt pavement and concrete sidewalks in the epicentral area (figs. 5.19 and 5.20). In some instances, local traffic was interrupted temporarily until these cracks were repaired. In most cases, damage was minor and local traffic was not interrupted. The south approach of Balboa Boulevard at SR118 caved in because of loss of abutment fill due to a water main break (fig. 5.21). This bridge was closed for traffic due to some structural damage to the piers and the loss of the south abutment fill, as described in chapter 4.

Figure 5.19. Transverse cracks in pavement along Balboa Boulevard in Northridge area.

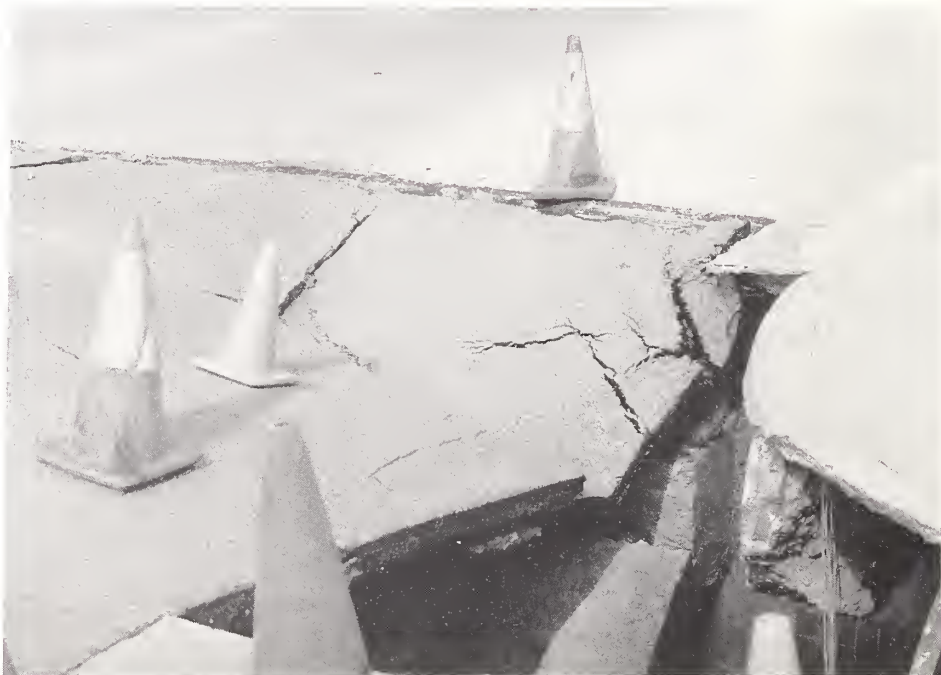
Figure 5.21. The approach of Balboa Boulevard at SR118 caved in due to the loss of the abutment fill because of a water main break.
